October 23, 2019

RE: Wind Damage Assessment for the Cedarville Township Building Located at 78 North Main Street, Cedarville, Ohio 45314 (19-811-NPM).

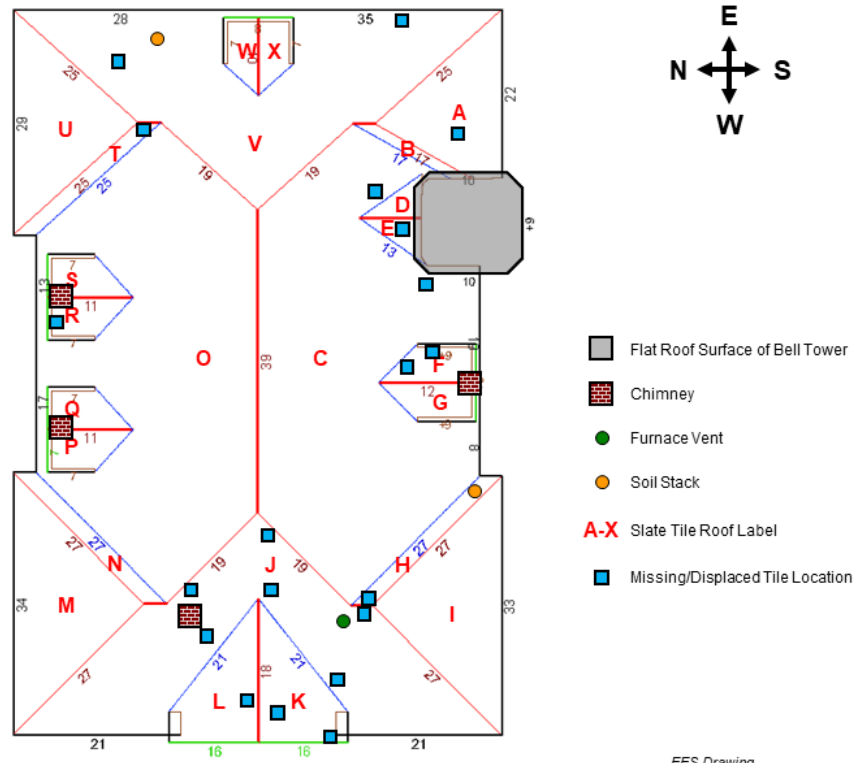
Figure 2: Roof Layout

- The metal flashings and appurtenances (i.e., valleys, ridges, hips, chimney flashings, roof penetrations, etc.) showed signs of long-term weathering and deterioration.
- The mortar joints on some of the chimneys were deteriorated and/or missing in some areas.
- A total of approximately 20 missing/displaced slate tiles were observed on the roof surfaces. Approximate locations of the damages are provided in Figure 2 below, and details are provided in Table 1.

As shown above in Figure 2 and Table 1, a total of 20 tiles, or approximately 0.10% of the roof surfaces contained missing/displaced tiles that could be the result of wind forces.

- A total of 20 slate tiles were missing/displaced and may have occurred as a result of wind forces.
- The minor areas of damage would warrant spot repairs of the tiles, likely using a 3:1 reparability factor to replace the slate tiles. This would indicate an additional ~60 tiles could be damaged during the replacement of the missing/displaced tiles.

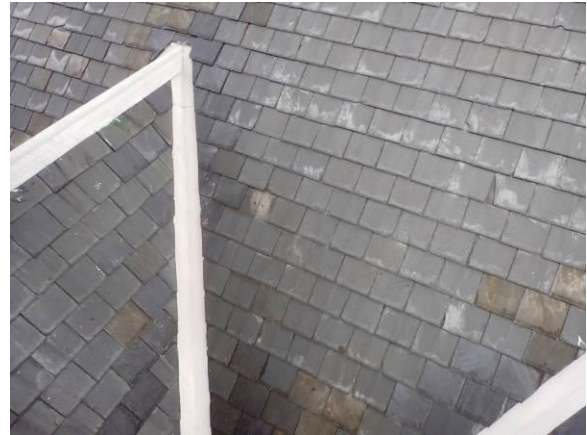
Roof – “D” Slope – Missing Tile near Valley

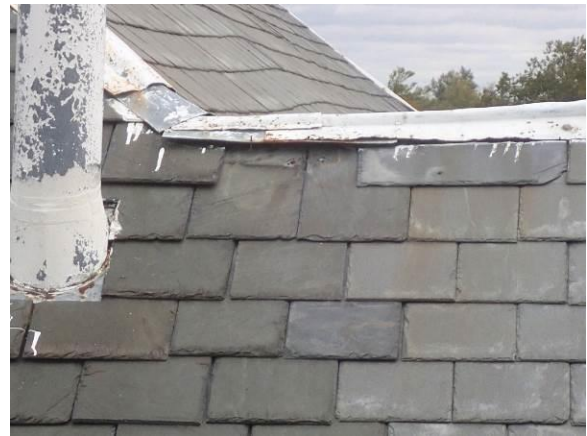
Roof – “J” Slope – Missing Tile near Ridge

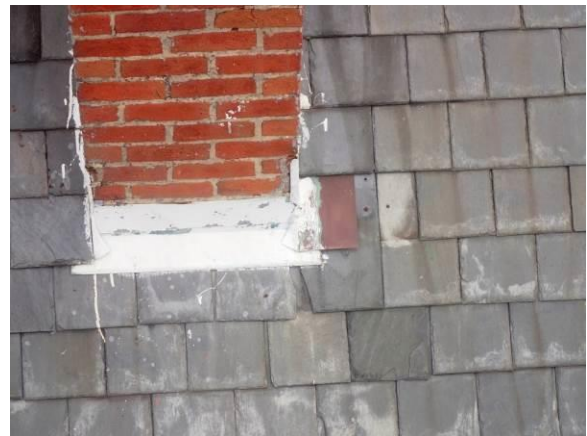
Roof – “J” Slope – Missing Tile near Chimney Penetration

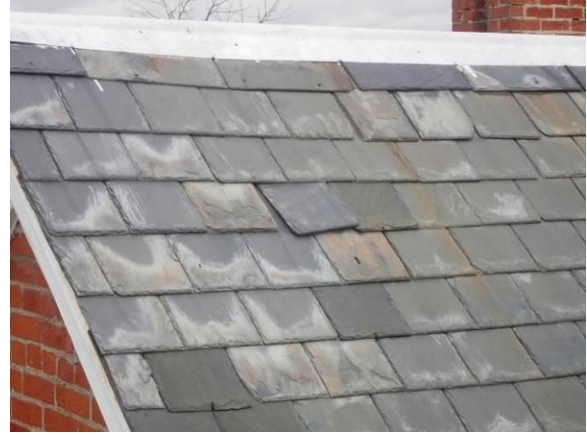
Roof – “K” Slope – Displaced Tile

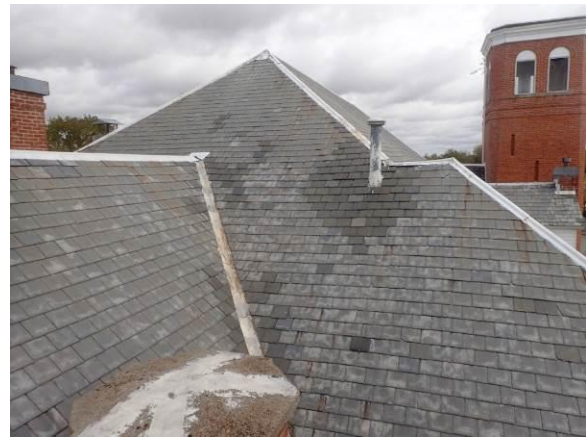
Roof – Replacement Tiles on West Slope

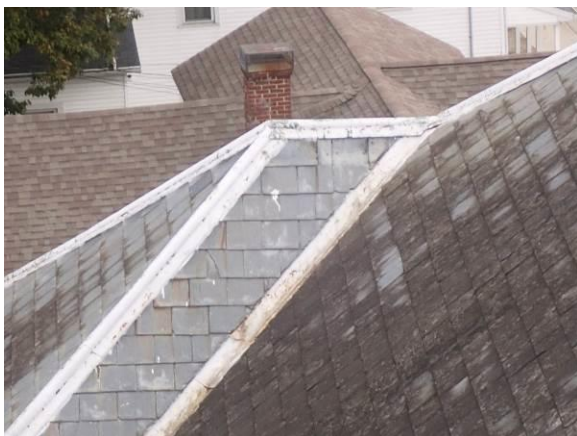
Roof – “L” Slope – Missing Tile near Ridge

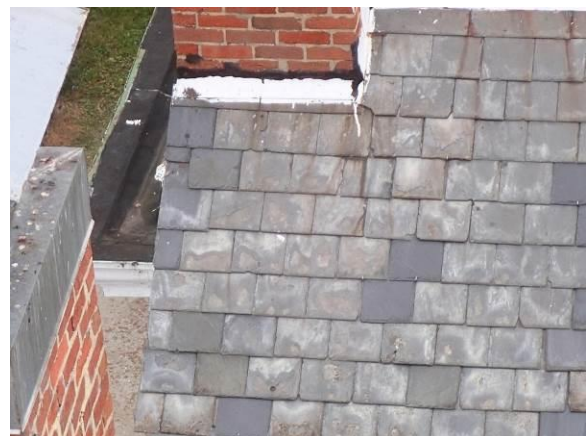
Roof – “Y” Slope – Missing at Rake Downslope of Chimney
